PACIFIC MARITIME ASSOCIATION

Safety Bulletin

Issue: 01 - 2019 February 2019

Cal/OSHA Appeals Board Decision involving the Discharge of Cargo Containers

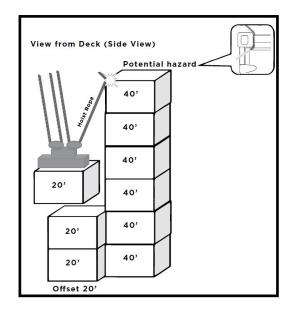
PCMSC Rule 1525

NOTE: Employees should not work in the area directly beneath a suspended load. When on-deck 20' containers are stowed offset of an abreast 40' container stack, the hoist ropes can align with corner castings. The slack hoist ropes can snag on the corner castings, causing containers to be pulled down. This can also damage the integrity of the hoist ropes. Therefore, the following protocol shall be used:

(d) Offset 20' containers abreast of 40' containers that cannot be twinned shall never have more than a two (2) tier height differential when being discharged or loaded (see U-1 and U-2).

- (a) Bay plans shall identify and note whenever on deck 20' containers are abreast of 40' containers.
- (b) Supercargo and Foremen shall be notified of such bays prior to the start of the shift.

(c) Foremen shall notify all longshore personnel working such bays prior to turning to.

(e) All hoist ropes that have been snagged on a corner casting of the abreast 40' container shall have an inspection of the affected area on the hoist ropes performed prior to the crane being put back into service.
